COMPOSITE REPAIR SPECIALIST

- **TYPE OF DEFECT :** Dent defect in subsea environment with **ZERO VISIBILITY**
- **PIPE DETAILS :** **36" OD – operating temp. 25°C – max. op. pressure 362 psi**
- **LOCATION :** **Qua Iboe Terminal – Offshore Nigeria (BOP)**
- **CLIENT :** **Mobil Producing Nigeria (MNP)**
- **3X PRODUCT :** **REINFORCEKIT 4D SUBSEA (R4D-S)**

OVERVIEW

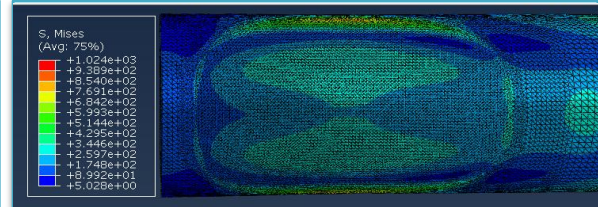
Design of the repair by Finite Element Analysis.

- After Finite Elements Analysis (FEA), 50 composite layers of **REINFORCEKIT 4D SUBSEA (R4D-S)** product have been determined to perform the reinforcement designed for 5 years.

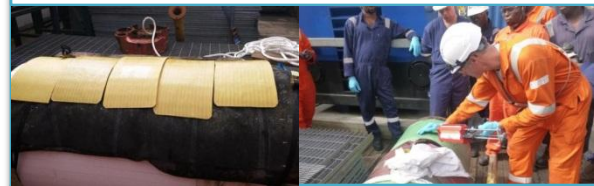
Composite plate manufacture on the foot print of the dented area & primer application (training picture).

1/ A foot print of the dent has been done in order to manufacture appropriate composite rigid plate.

2/ Primer (P3X32) application on the defect, using a dispensing gun, to provide a good adhesion of the composite materials.

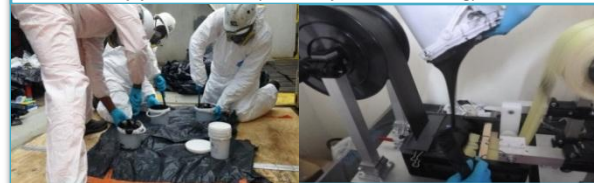
Mixing of the resin and tape impregnation using BOBIPREG (3X specific tool) to avoid lack of resin.

4/ Kevlar® tape pre-impregnated with R3X1050-S resin (using special 3X device called BOBIPREG) wrapped around the pipe. 82 Kevlar® rolls were necessary to cover the dent with the appropriate thickness composite needed.

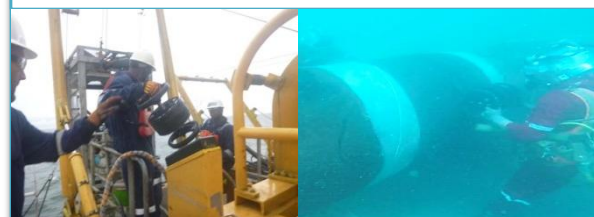
3X divers wrapping tool sent on a basket for divers & divers composite application (ILLUSTRATING PICTURE ONLY).
