COMPOSITE REPAIR SPECIALIST

- **TYPE OF DEFECT :** Dent damage in subsea environment
- **PIPE DETAILS :** 16" OD – design temp. 65°C – design pressure 92.5 barg
- **LOCATION :** VIET-NAM, Su Tu Vang
- **CLIENT :** PV GAS
- **3X PRODUCT :** REINFORCEKIT 4D SUBSEA (R4D-S)

OVERVIEW

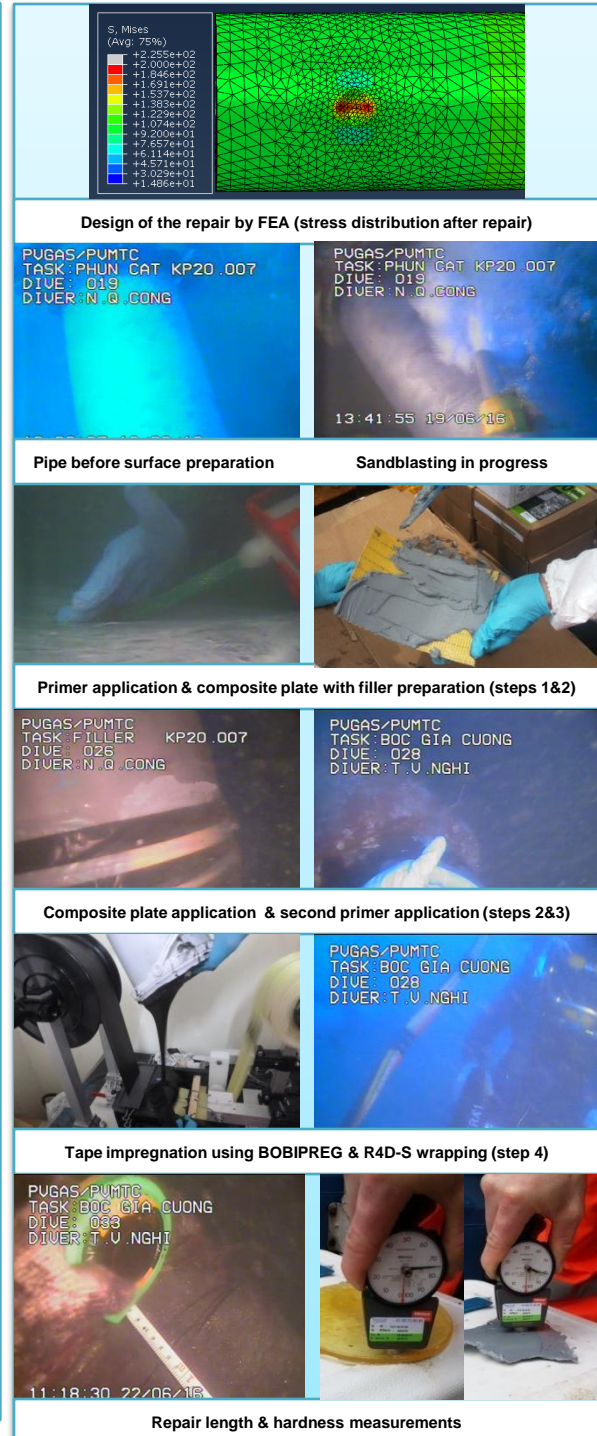
The objective of the repair performed in June 2016 by 3X ENGINEERING (3X) and its local distributor PETROENERTECH was to **reinforce a damaged subsea pipe section over 1 meter length, due to dent defect situated at 55-meter depth (3.3 % dented depth).**

4/ Kevlar® tape pre-impregnated with R3X1050-S resin (using special 3X device called BOBIPREG) wrapped around the pipe. Thirty layers were necessary to cover the dent (i.e. 15 passes of 50% overlap).

The 16" sea line was efficiently completed within 2 days. The total length of the repair was 1.05m. This project was a big challenge because of the 55-meter depth which is a very restrictive environment and needs diving limited times. Thanks to our experience in subsea repairs added to the great collaboration between PETROENERTECH, PV GAS representatives and PVMTC divers, this subsea repair was one more success.
