COMPOSITE REPAIR SPECIALIST

TYPE OF DEFECT: Severe external corrosion spots & leaking defect

PIPE DETAILS: 20" Gas pipeline - max. operating temp. 60°C – design pressure 172 barg

LOCATION: IRAN

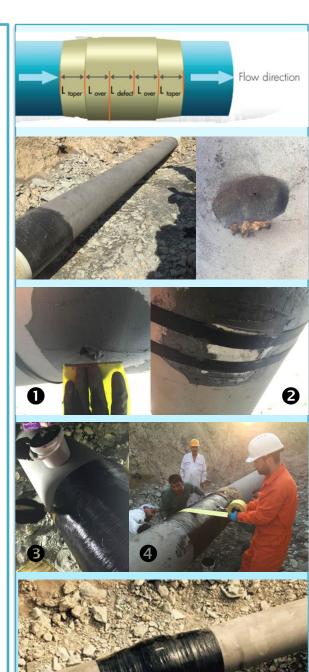
The objective of the repair performed in August 2015 by 3X ENGINEERING and its local exclusive distributor TAVANA PIPELINE ENGINEERING was to reinforce and stop corrosion on localized area of the pipe (several external corrosion spots and one 1mm diameter hole).

- After calculations and Finite Elements Analysis (FEA), 68 layers have been determined to perform the repair.
- Because of the leaking defect the repair has been performed offline. An initial sandblasting has been made prior 3X intervention to get a good surface roughness (75-micron surface profile).

- 1/ Special filler (F3XS1) application to rebuild the surface.
- **2/** Metallic steel plate (with filler), fixed with straps during curing time, installed over the defected area.

- **3/** Second filler application performed to ensure the proper impregnation of the first layer.
- **4/** Wrapping using Kevlar and R3X1080 resin. 68 layers of composite (over 88cm) were applicated to reinforce the pipe i.e. 34 passes (50% overlap).

- Identification plate for traceability has been positioned on the pipe. Curing time of the composite system required 50°C during 3 days. This curing process has been initiated with heating blanket during 72 hours.
