COMPOSITE REPAIR SPECIALIST

- LOCATION: FPSO MONDO (ANGOLA) – Block 15
- DATE OF PROJECT: April 2015
- PIPE: 12" water injection / thickness:38,1mm
- ID LINE: WI-M26002-25C02
- TYPE OF DEFECT: Hole in between flanges
- DESIGN PRESSURE: 344 bars
- TEMPERATURE: 35°C
- 3X SOLUTION: REINFORCEKIT 4D

REPAIR PERFORMED BY OUR LOCAL DISTRIBUTOR

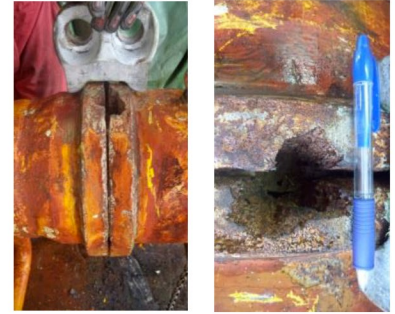
A whole in between 2 flanges on a 12" water injection line surrounded by a Galperti clamp

Surface was to be prepared by using the pneumatic bristle MONTI brush to obtain the appropriate roughness. Filler (F3X8) was injected manually in between the flanges to fulfill the hole (refer to pictures on the right). In order to improve the wrapping, 2 layers of kevlar (100mm width) was covered by the filler and applied on the outside diameter of the connection (see 4th picture) Then IC resin (R3X5) was applied also with 100mm width kevlar bandage around the connection to prevent further leakage (see 5th picture). The Galperti clamp was put bolted back on the connection to insure maximum resistance. At last, filler was applied in between the gap of the clamp and the line to definitely seal the leak (refer last picture).
