3X Engineering repairs subsea dent with zero visibility

The objective of the repair performed in September 2016 by 3X ENGINEERING and its local distributor SAVIC was to reinforce a 2.5m length of damaged subsea pipeline. The dent defect (13,1 % dented depth) was situated at 16m depth with zero visibility on a 36 inch diameter pipeline Offshore Nigeria.

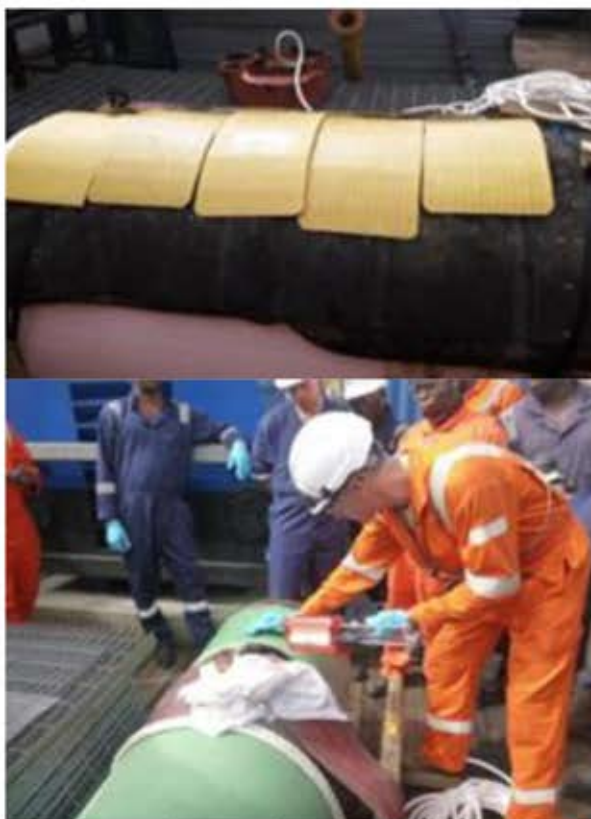
Composite plate manufacture on the foot print of the dented area & primer application (training picture). ●

1. A foot print of the dent was made in order to manufacture appropriate composite rigid plate.
2. Primer (P3X32) was applied to the defect, using a dispensing gun, providing a good adhesion of the composite materials.
3. Five rigid composite plates covered with F3XSS filler were positioned over the dent and strongly fixed with ratchet belts for a curing time of 3 hours (*illustration picture*).
4. 82 rolls of Kevlar® tape, pre-impregnated with R3X1050-S resin, using a special 3X device called BOBIPREG) were wrapped around the pipe.
5. Finally, a neoprene soft cover was applied to protect the repair from shells and other elements.
