# WORLD PIPELINES®

Volume 18 Number 11 - November 2018

### Experimental procedure – full-scale testing

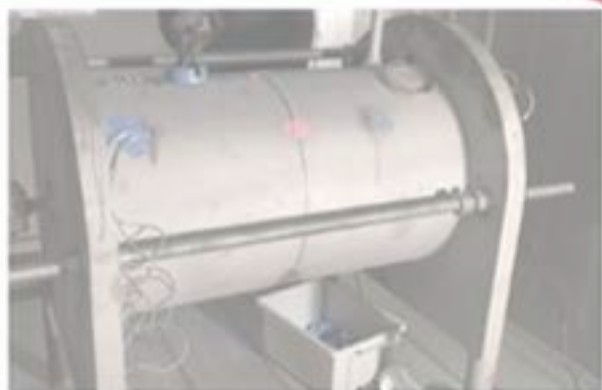
Figure 4. Welded pipe set-up.

Two configurations of the pipe were tested: leaking and non-leaking. The leaking configuration was tested first using four different repair configurations. Composite wraps were applied and subsequently tested to their maximum pressure on a test spool designed to simulate a failed weld. The test pipe set-up is shown in Figure 4. The test pipe was held together during the full crack simulation by two 10 cm long welds located at the 140° and 220° circumferential locations. Following the through wall leaking testing, a full circumferential weld was applied and two more tests were performed. The weld thickness in this second test set-up was 15% of the pipe thickness to simulate an 85% wall loss defect.
