## CPPI inspects pipeline with triaxial MFL tool in Thailand

## 3X Engineering repairs subsea dent damage in Vietnam

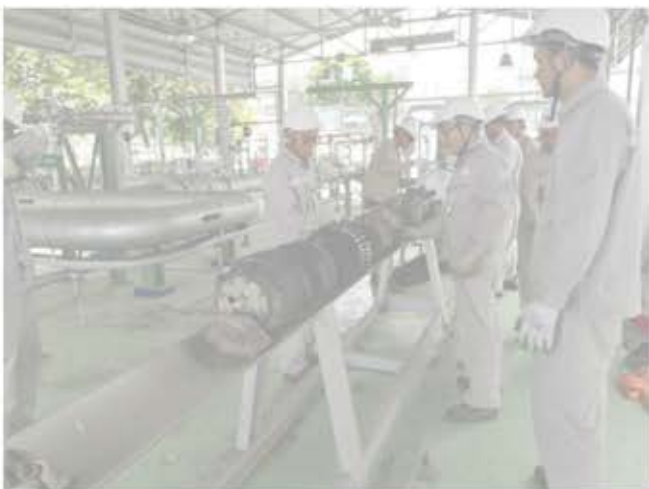
CPPI's triaxial magnetic flux leakage (MFL) inspection tool. ●

China Petroleum Pipeline Inspection Technologies Co., Ltd (CPPI) team successfully inspected a 11.5 km-long, 10 inch diameter gas pipeline in mid August for PTT company, Thailand with a triaxial magnetic flux leakage (MFL) inspection tool.
