# COMPOSITE REPAIR SPECIALIST

- **TYPE OF DEFECT :** Crack on elbow (GRE pipe)
- **PIPE DETAILS :** 10" GRE water pipeline – design pressure 10 bars
- **LOCATION :** GABON
- **3X PRODUCT :** REINFORCEKIT® 4D (R4D)

The objective of the repair performed in December 2016 by 3X local exclusive distributor FRIEDLANDER was to **repair a 10" GRE pipe damaged by a crack.**

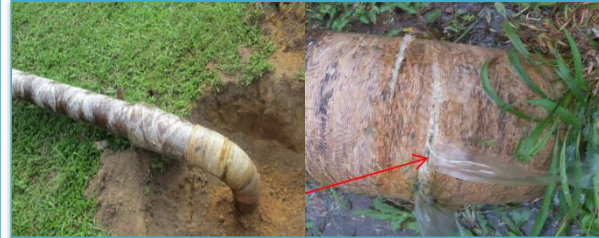
View of the elbow and leak point prior repair

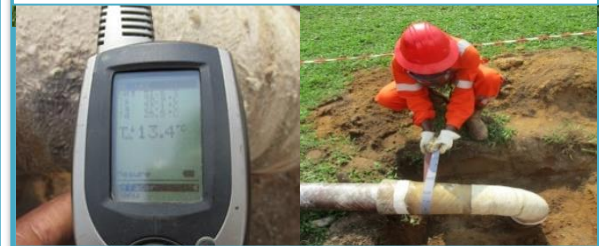
Climatic conditions measurements and surface preparation

- Prior wrapping, surface preparation was performed with sandpaper to allow the resin to adhere on the pipe surface.

- Climatic conditions have been checked using hygrometer and the surface has been cleaned and degreased with acetone.

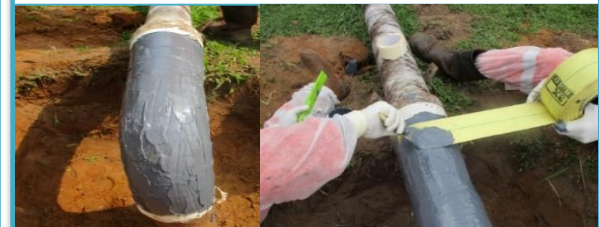
Mastic application and wrapping process with Kevlar® tape and resin

**1/** F3X8 filler application on the whole surface to be treated in order to plug the defect and rebuild the surface.

**2/** Wrapping process was then started using Kevlar® and R3X5 resin  
→ 16 layers of composite over 960mm were applied.

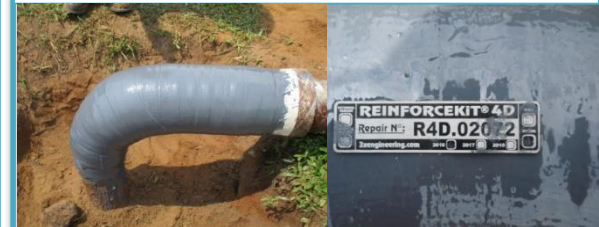
View of the elbow after wrapping and id plate positioning

- Identification plate has been positioned on the pipe for traceability process.

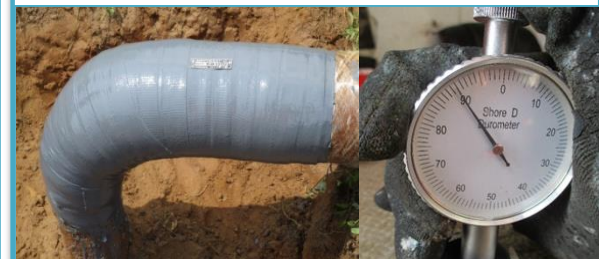
View of the repair completed and hardness measurements

- Hardness measurements have been performed 72 hours after job completion and the values were superior to the minimal requirements → composite is well polymerized and operational. Pressure can be applied.
