# COMPOSITE REPAIR SPECIALIST

- **TYPE OF DEFECT :** Axial Slot External Corrosion in Subsea Environment
- **PIPE DETAILS :** 10" OD - max 50°C pipe temp. - 20 bar design pressure
- **LOCATION :** INDIA
- **3X PRODUCT :** REINFORCEKIT 4D SUBSEA (R4D-S)

The objective of the repair performed in December 2014 by 3X ENGINEERING and its local distributor 3X INDIA was to **reinforce 11 leaking defects over 1.7 meter length of a subsea pipe section due to severe corrosion.**

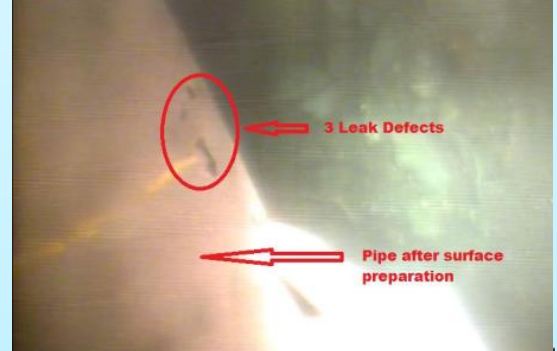
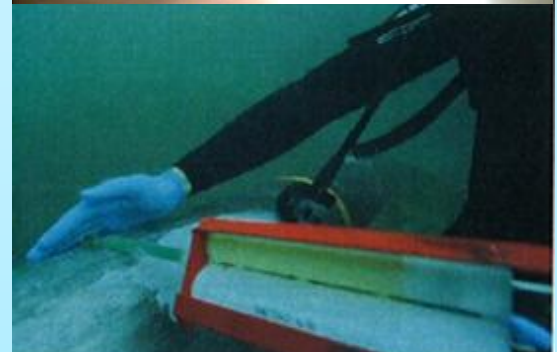
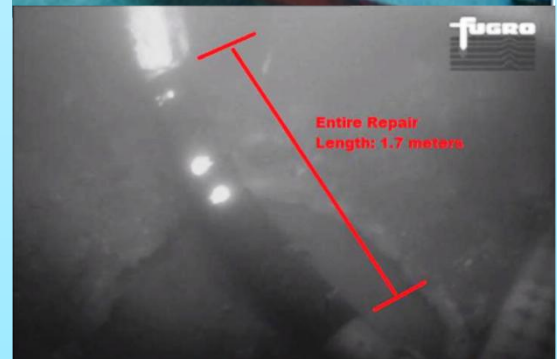
Based on its experience acquired during two recent subsea projects on 32" pipe at 62-meter depth, 3X Engineering has been able to conduct with success this complicated job. Applying our products in deep water is very sensitive and needs to be performed with high-qualified staff and high-performance equipments. This pipe repair was successfully completed and after service, no leak was observed.

- Underwater, after removal of metal clamps and concrete over the pipe, a surface preparation was performed to get a good surface roughness (60-micron surface profile).

- The wrapping repair has been performed following several stages :

1/ Special subsea filler (F3XSS) application to fill the leaks and provide a solid and smooth curvature.

2/ Sandblasted thin steel plates (with filler), fixed with straps during curing time, installed over the defected area.

3/ Second filler application performed to ensure removal of sharp edges and stress concentration areas.

4/ Primer application on the entire repair using a gun with bi-component cartridge.

5/ Wrapping using Kevlar and R3X1050-S resin on the whole repair surface (steel plates and pipe) to avoid differences of level and to increase quality of the 1<sup>st</sup> layer wrapping.

- A protective cover has been applied to protect the recently installed layers and a 72-hour curing time has been allowed before pressuring the pipe.
